MARCOS CARS OF AMERICA

PRE 1971

MANUAL

Essex 3-litre V6

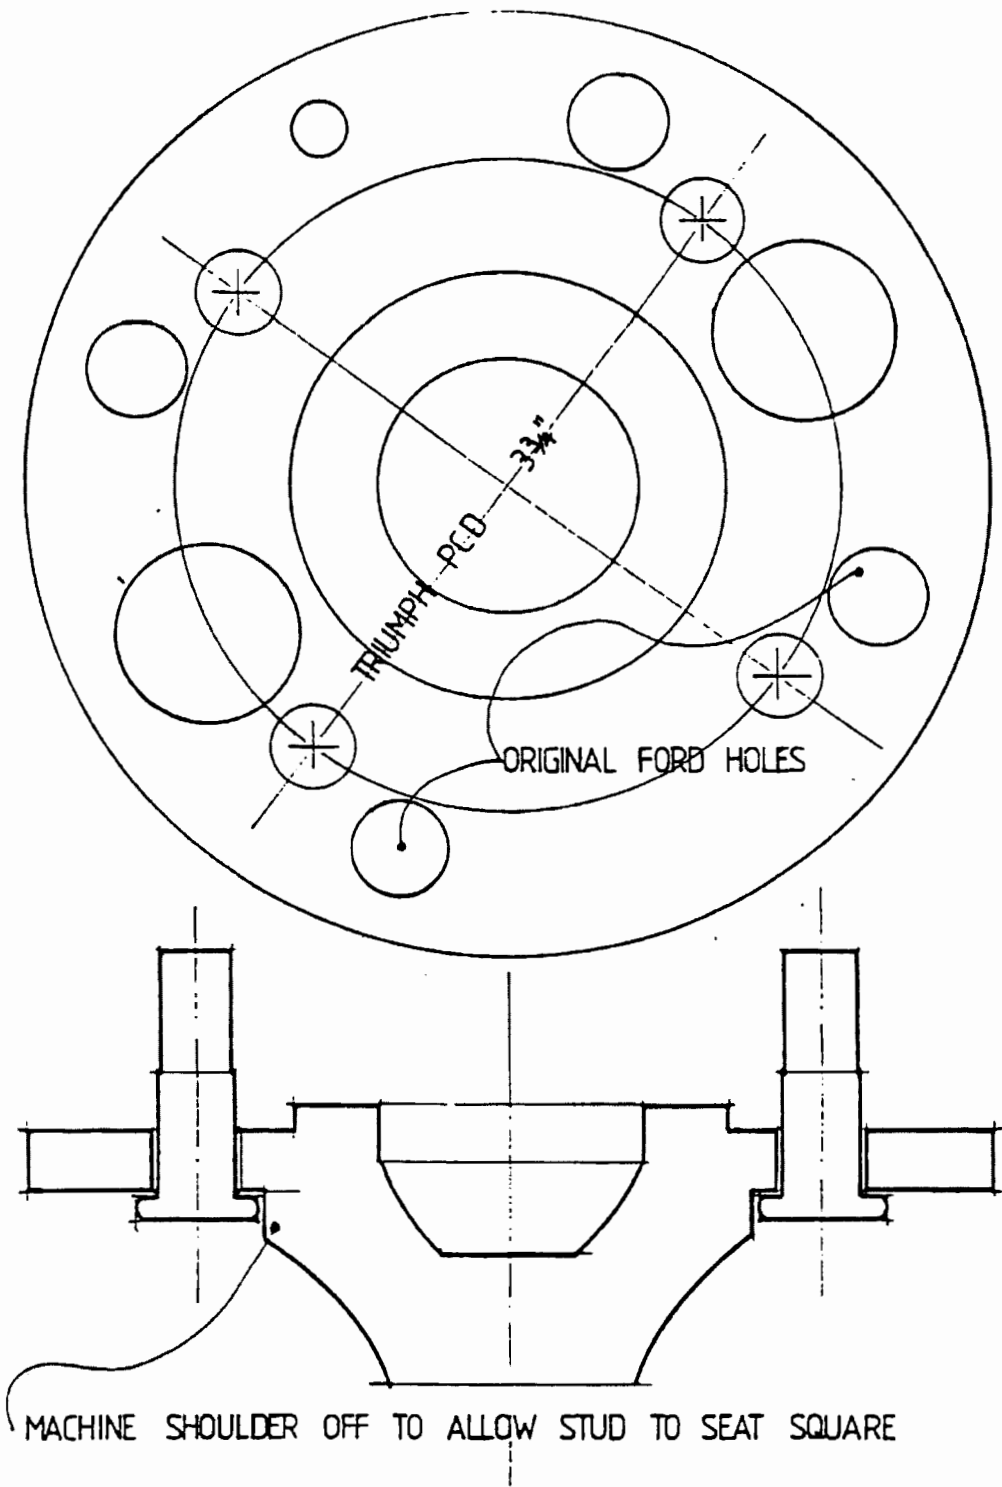
HALF SHAFT MODIFICATIONS
FIGURE A

REDRILL BRAKE DRUM THE SAME

Rear Axle if using rear axle other than supplied by Marcos, You should check for bearing and oil seal leakage which could leak onto brake shoes. In the rear of this manual is a diagram of the Marcos rear suspension set up. The brackets must be attached correctly and by electric welding other than gas welding which might cause axle shaft heat distortion. You would also have to change rear brake drum bolt pattern to match the front as in figure A.

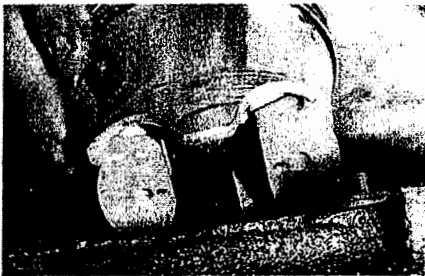
Pistons and con rods can then be pushed out from below. Ours were almost new.

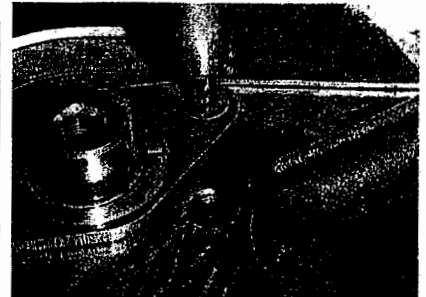
Firm whacks will shift these screws, but take care not to break the thrust plate.

THE CAMSHAFT was next to come out. This is held by a thrust plate, and the two screws securing this can be difficult to shift because of the locking compound on their threads. An impact screwdriver should shock them loose, but don't use too much

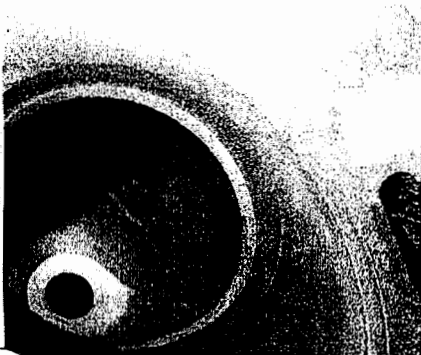
Minimal marking on valve seat faces, so they could have been lapped-in at home.

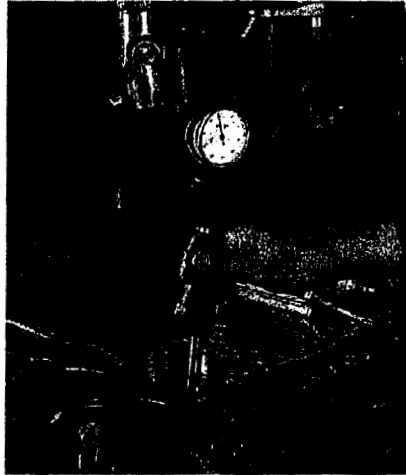
If you want to re-use pistons, first check that bores and pistons are the same size.

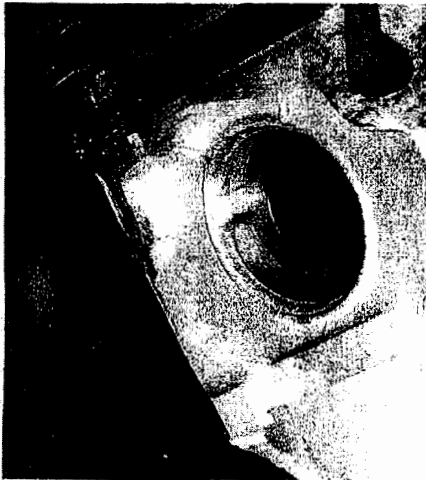
... and ensure the piston bosses round the gudgeon pin are smooth and undamaged.

where the piston boss rotates around the pin. Dave couldn't feel any movement when he tried pulling the piston up and down along the conrod and, with the piston slid to one end of the pin, there was no sign of any metal being scraped off the piston boss. So he settled on taking 0.0005in off the bores, basically just enough to take off the glaze and clean the lip at the top, and fitting a new set of rings.

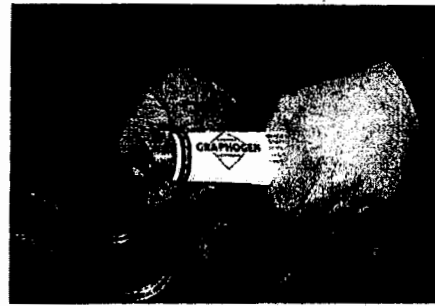
Assembly compound sticks to bearings for longer than engine oil if engine is stored.

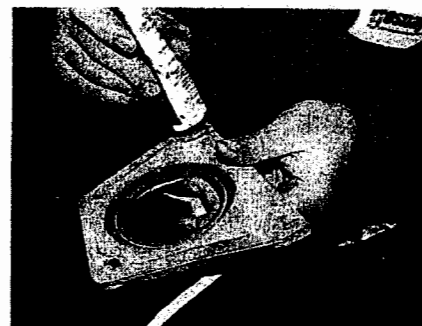
A non-setting sealing compound helps to stop thin paper gaskets from leaking.

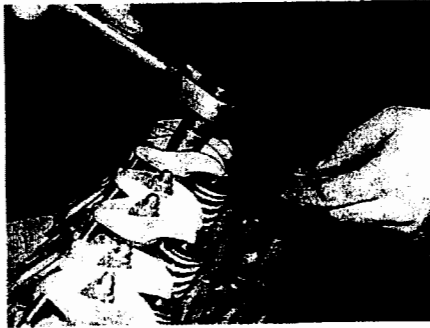
If gaps are hard to get right, make sure that the finger hasn't moved off-centre.
